2013 Pedestrian Accessibility Study

Somerville, Massachusetts

FAY, SPOFFORD & THORNDIKE

May, 2013

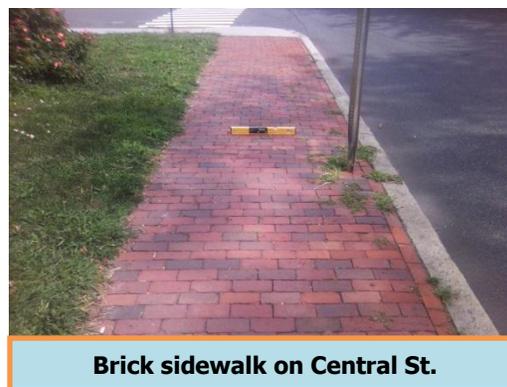
Brick sidewalk on Central St.

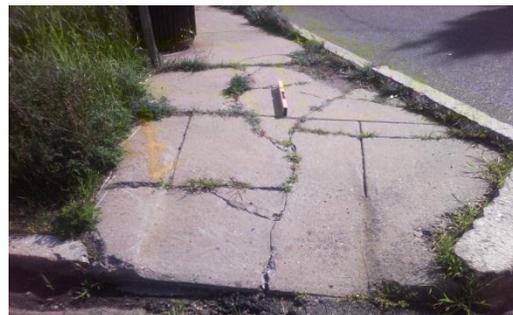
Poor ramp in need of Full Replacement

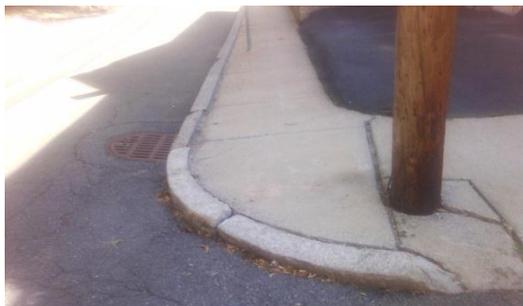
Ramp is missing with no crosswalk

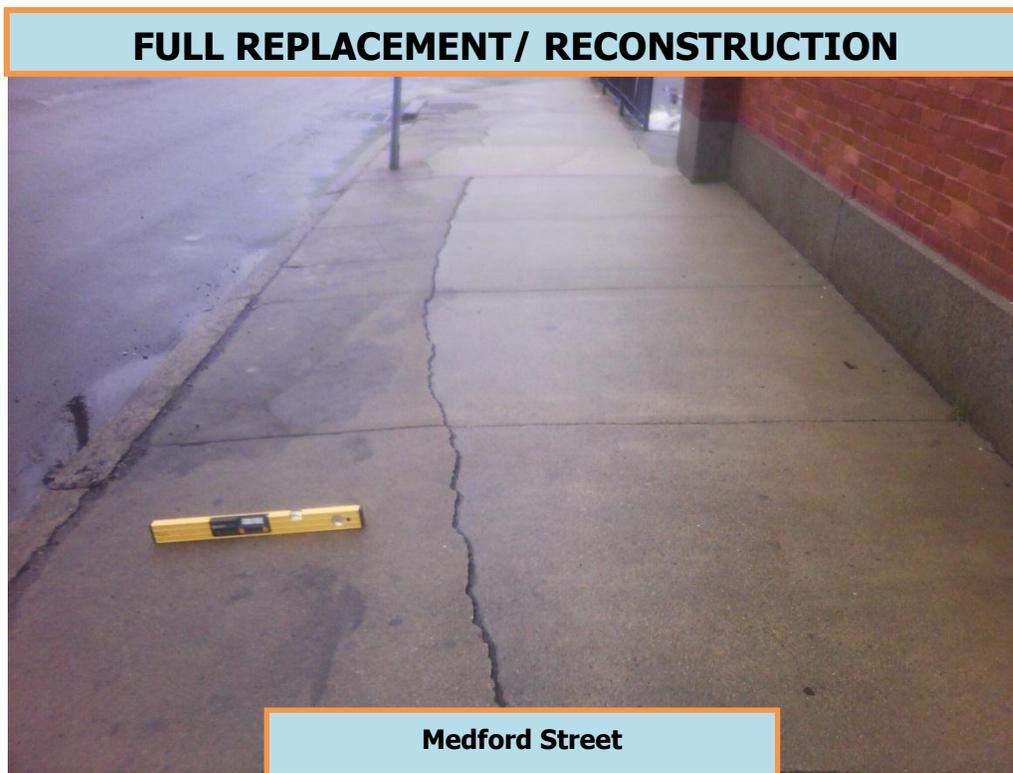
The figures below show the visual difference between the three categories:

- 0-49 = Full Replacement/ Reconstruction
- 50-79 = Localized Repairs/ Panel Replacement
- 80-100 = Do Nothing

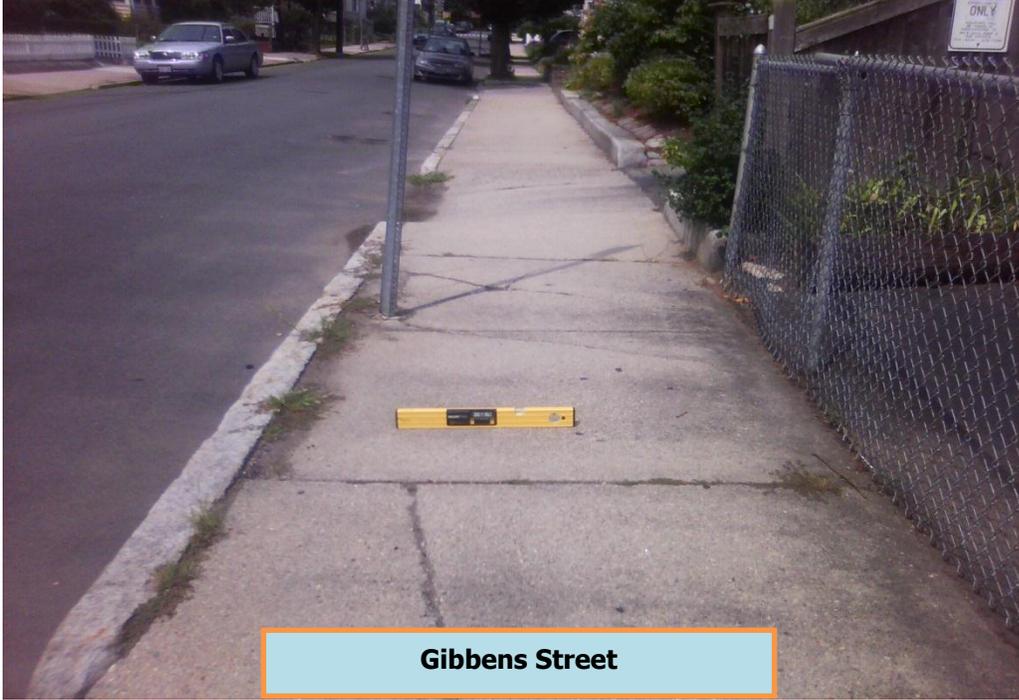
Gibbens Street

LOCALIZED REPAIRS

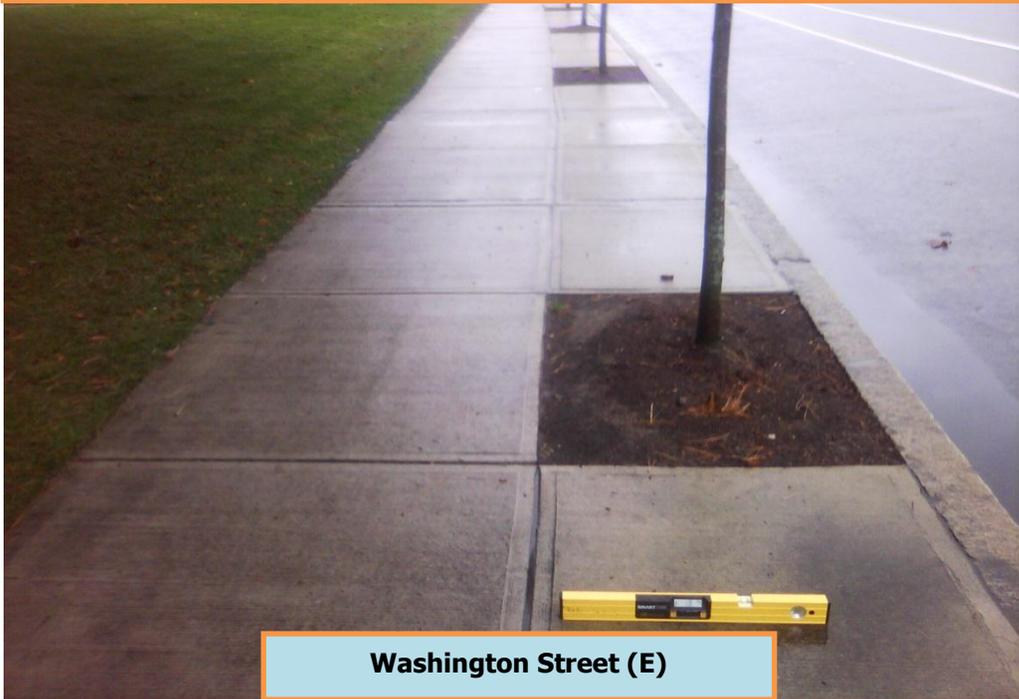
Washington Street (E)

DO NOTHING
