# ROOME & GUARRACINO, LLC

Reference: 100 Fellsway West, Somerville, MA

Subject: Structural Evaluation for Renovation

**GEOTECHNICAL ENGINEERING  
EVALUATION**

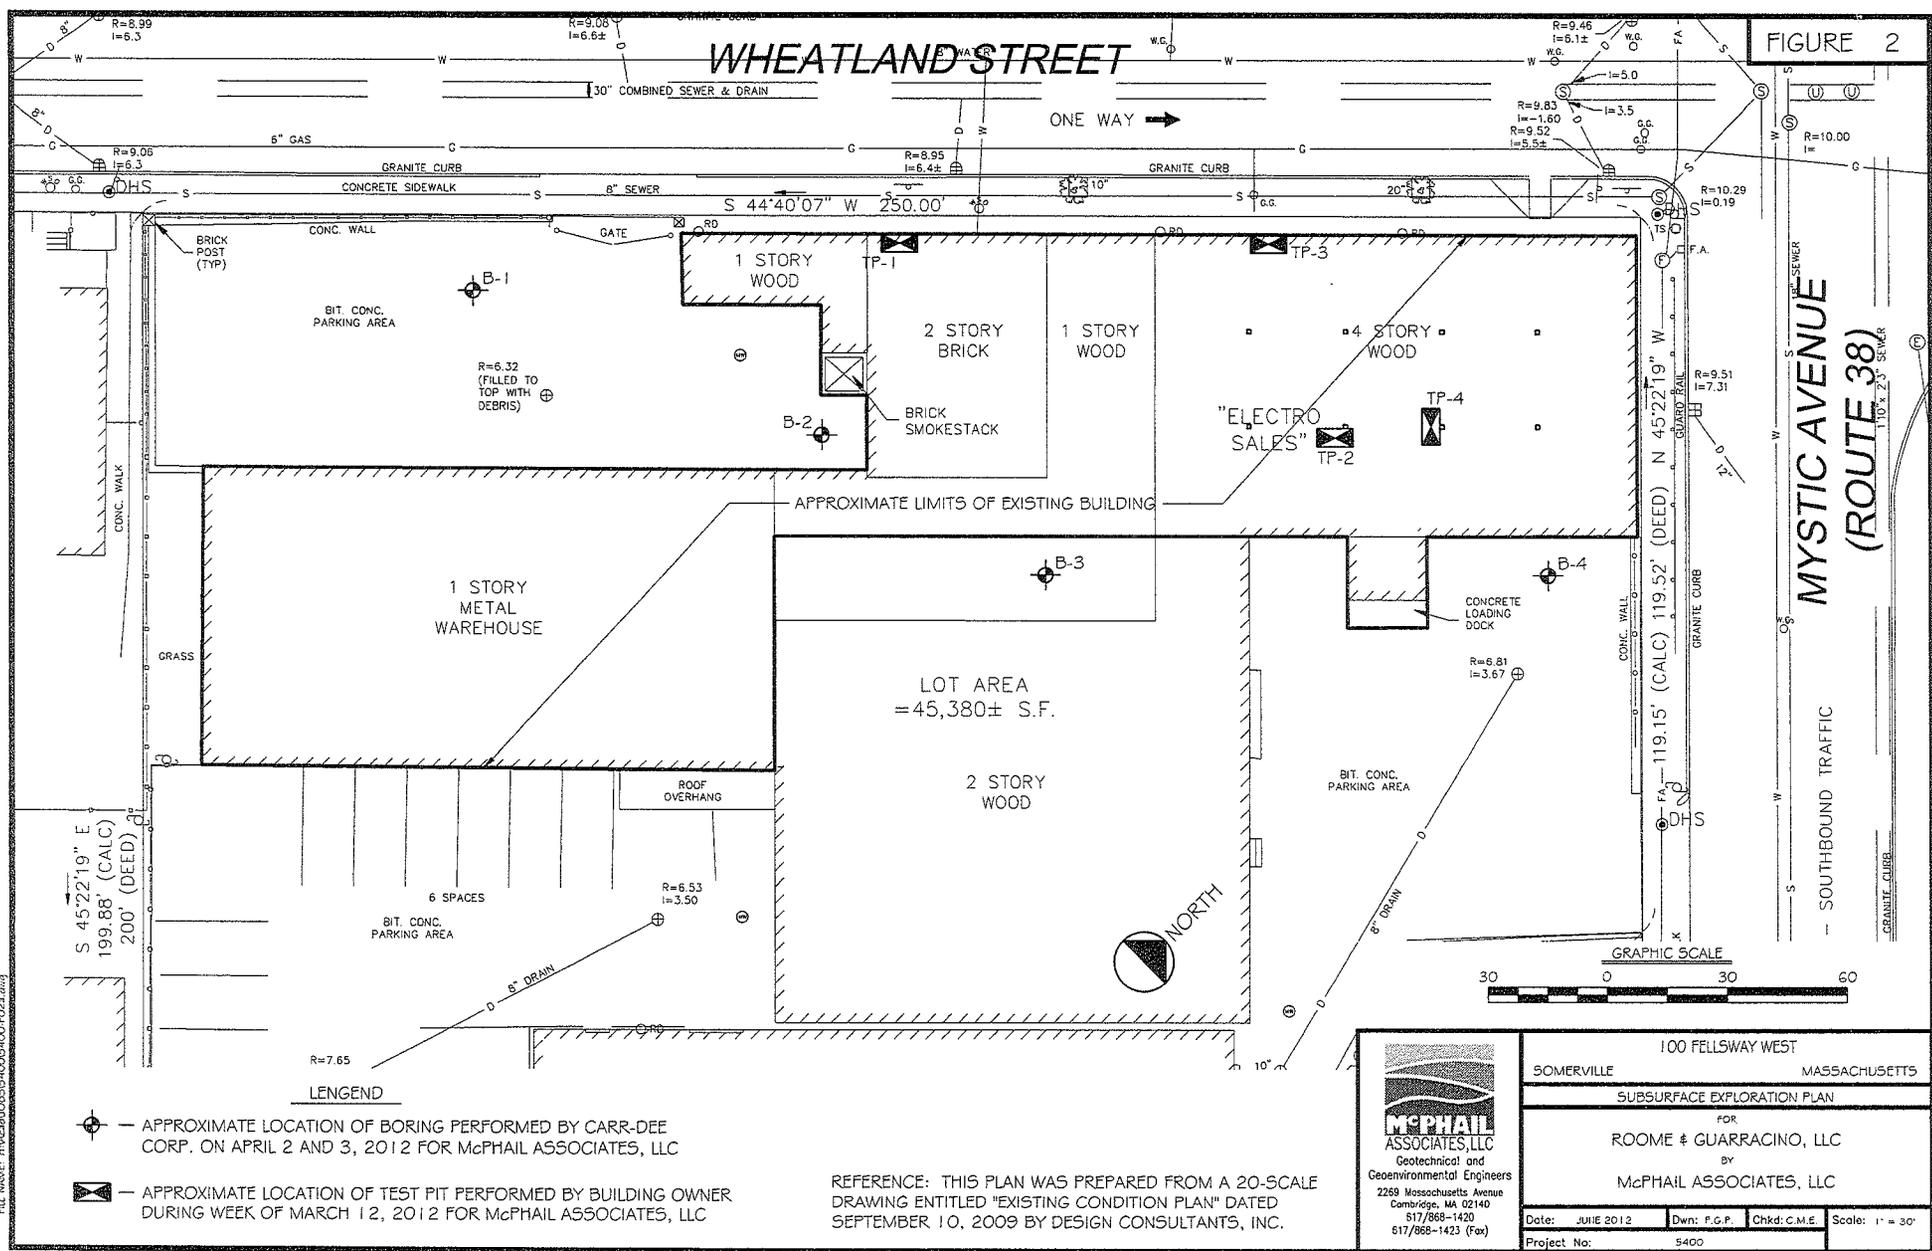
100 FELLSWAY WEST			
SOMERVILLE		MASSACHUSETTS	
SUBSURFACE EXPLORATION PLAN			
FOR			
ROOME & GUARRACINO, LLC			
BY			
McPHAIL ASSOCIATES, LLC			
Date: JULIE 2012	Dwn: F.G.P.	Chkd: C.M.E.	Scale: 1" = 30'
Project No: 5400

Two of the test pits (TP-1 and TP-3) were located along the interior side of the north exterior bearing wall. The remaining two test pits (TP-2 and TP-4) were performed adjacent to timber columns located within the building basement. The test pits were conducted during the week of March 12, 2012 and observed by a representative of McPhail Associates, LLC after completion on March 16 and 20, 2012. After removal of a portion of the concrete basement floor slab, the test pits were excavated to depths of approximately 4 to 4.5 feet below the top of the floor slab. Logs and photographs of the test pits are presented in Appendix B.

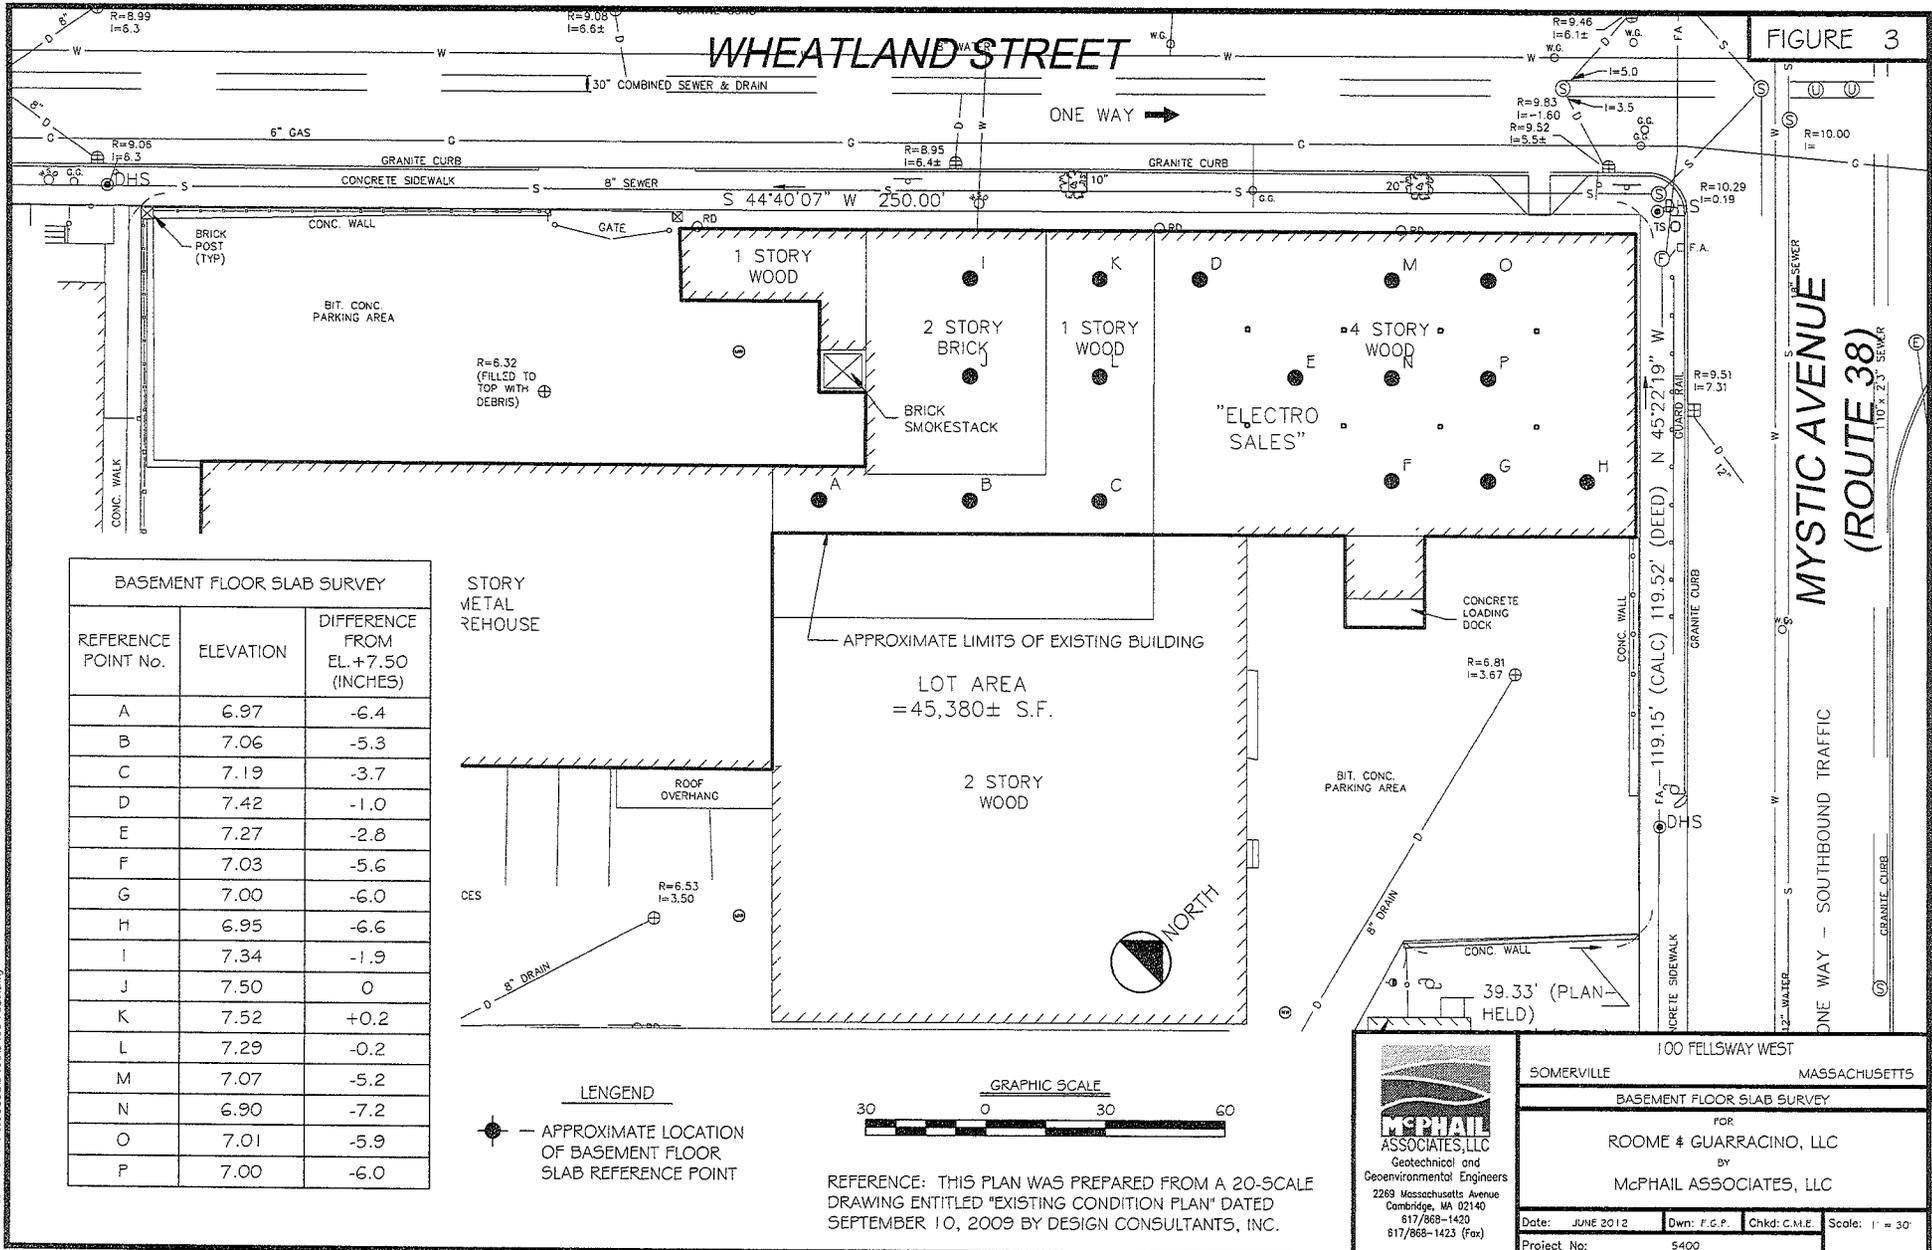
BASEMENT FLOOR SLAB SURVEY

During our subsurface exploration program, a level survey of the existing basement floor slab was conducted by a representative of McPhail Associates, LLC. The survey consisted of determining the elevation of sixteen (16) reference points spaced throughout the basement area as indicated on Figure 3. The measured elevation of each of the reference points is also presented on Figure 3.

The tabulated data presented in Figure 3 presents the difference in elevation among the reference points based on an assumed reference level of Elevation +7.5 which does not necessarily represent the original elevation of the basement floor slab. The Elevation +7.5 level was selected to evaluate the relative difference in measured elevations of the floor slab.

In consideration of the data presented in Figure 3, the existing basement slab is up to approximately 6 inches out of level. Although it cannot be determined how level the floor slab was originally constructed, based on the survey data and our observations, it appears that the floor slab has undergone several inches of differential settlement. It should also be noted that reinforcing steel was observed in the sections of floor slab removed from test pits TP-2 and TP-4 which would tend to reduce the magnitude of differential settlement across the floor slab.

In order to provide proper foundation support of the existing building in accordance with the current provisions of the State Building Code, it is recommended that new foundations be installed below the unsuitable fill and organic deposits and into the top of the stiff to very stiff marine clay deposit that underlies the building. Remedial foundation support would likely consist of conventional underpinning pits and drilled mini-piles installed across the building footprint. Replacement of foundation support below the basement column locations would likely require temporary shoring and removal of the existing isolated footings. In addition, in consideration of the observed condition of the existing basement floor slab, removal of the floor slab and replacement with a structurally-supported slab is recommended.

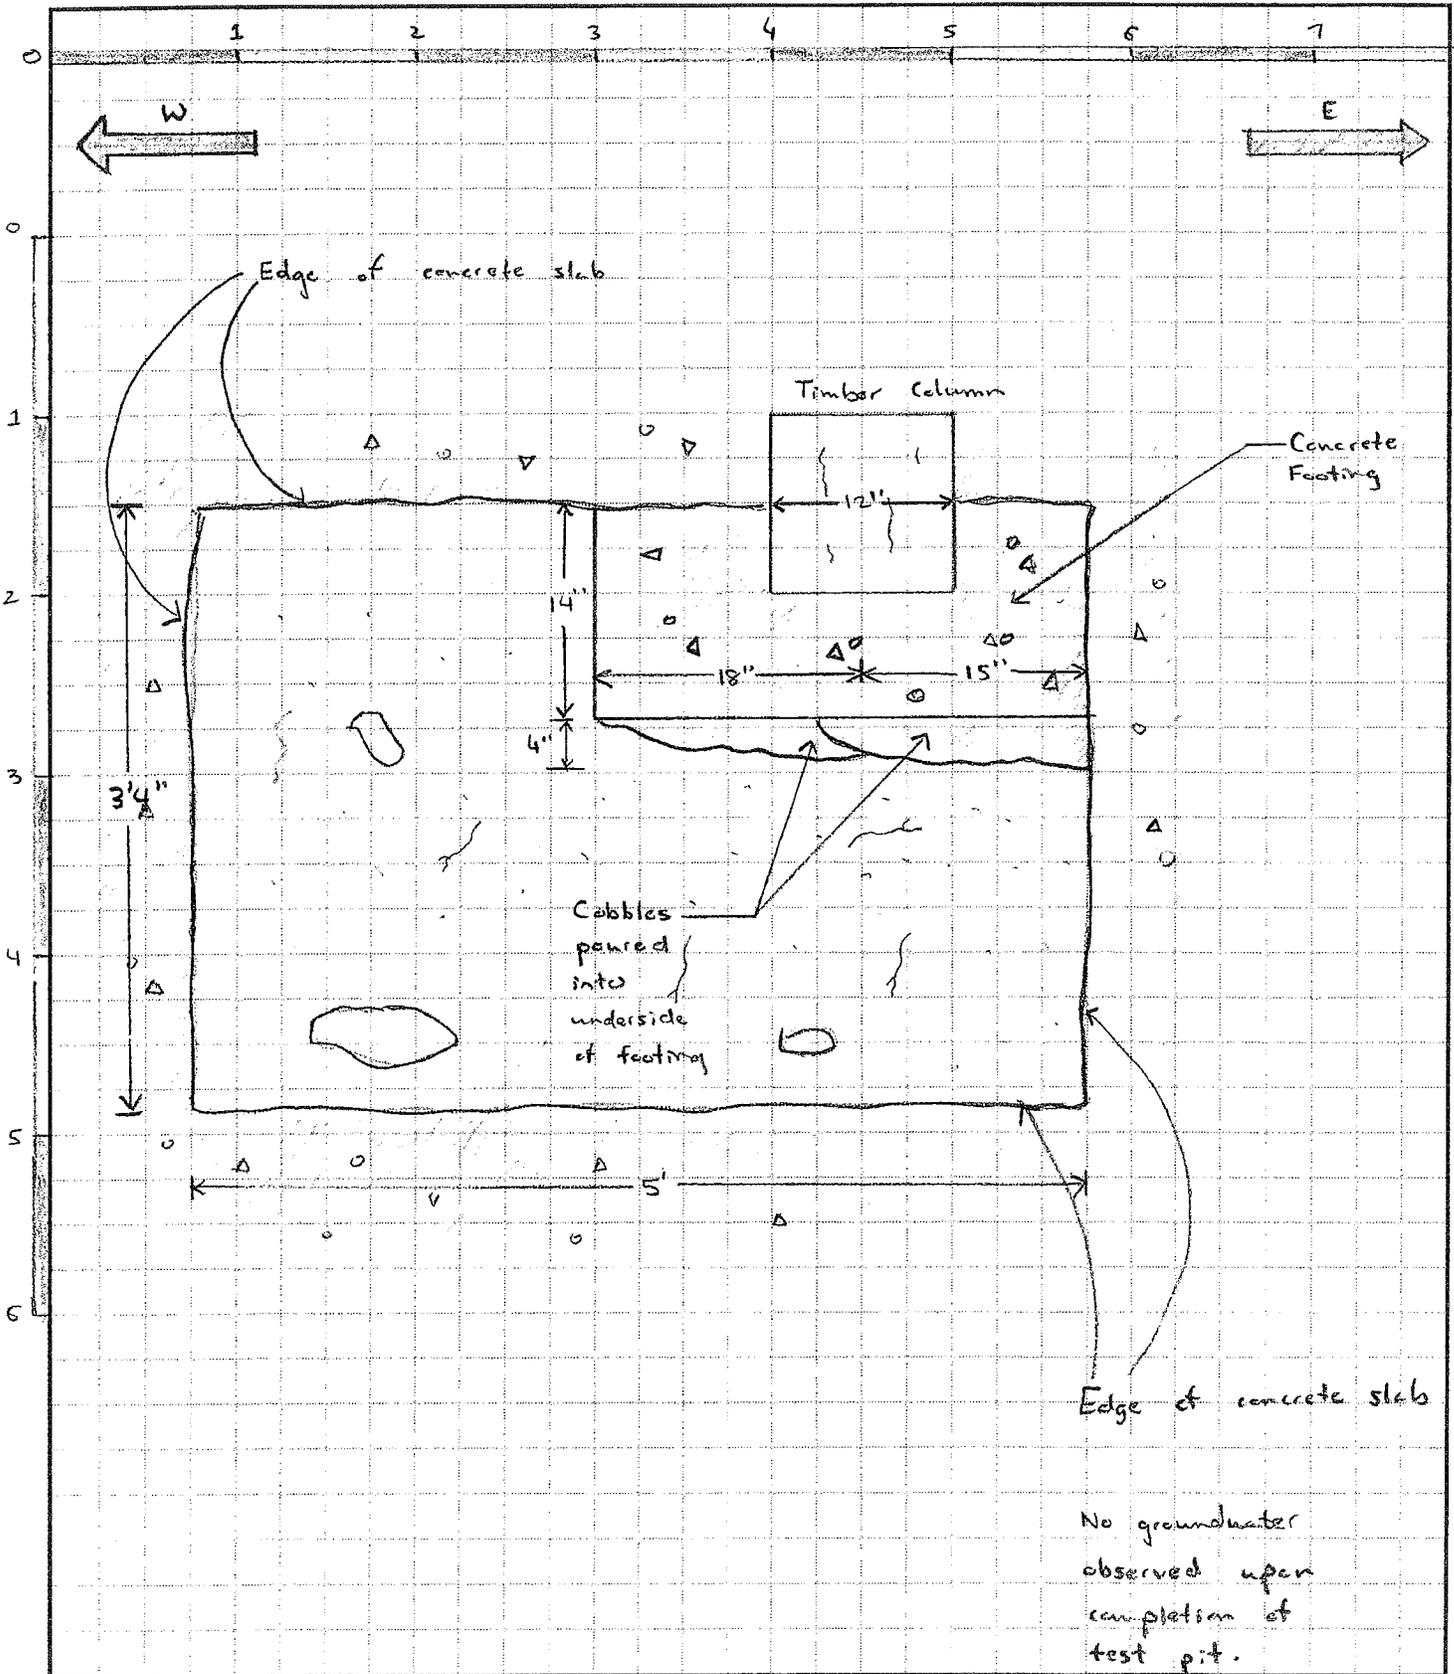
JOB 5400 TP-2 Plan View  
 SHEET NO. 3 OF \_\_\_\_\_  
 CALCULATED BY Scott Dennis DATE March 16, 2012  
 CHECKED BY CME DATE 3/30/12  
 SCALE 1" = 1'

Test pits performed adjacent to timber columns located within the building basement (TP-2 and TP-4), indicated the columns to be supported on isolated footings. The footings were observed to consist of a concrete base, varying in width from 3.5 to 4.5 feet and ranging in depth from 1.3 to 1.8 feet. At both test pits, the concrete was underlain by an unsorted mixture of cobbles and bricks varying from 10 inches to 2 feet in thickness. The bottom of the cobbles in the test pits extended to depths of 4.0 to 4.2 feet below the existing basement floor slab, corresponding to about Elevation +3.1, and were observed to terminate in the fill deposit. In general, the isolated footings exposed in the basement test pits did not appear to be "engineered" and typically consisted of a haphazard mixture of concrete, brick and cobbles.

Additionally, in both TP-2 and TP-4, the timber column was not observed to be concentric with the plan location of the underlying footing. At TP-4, the plan location of the timber column was observed to be at the outer edge of the footing concrete. It was also noted that the timber column at both test pit locations extended below the concrete floor slab and was significantly rotted to completely disintegrated within the depth that extended below the floor slab as indicated in the photographs contained in Appendix B. The cross-sectional area of the column was significantly to entirely compromised at both test pit locations.

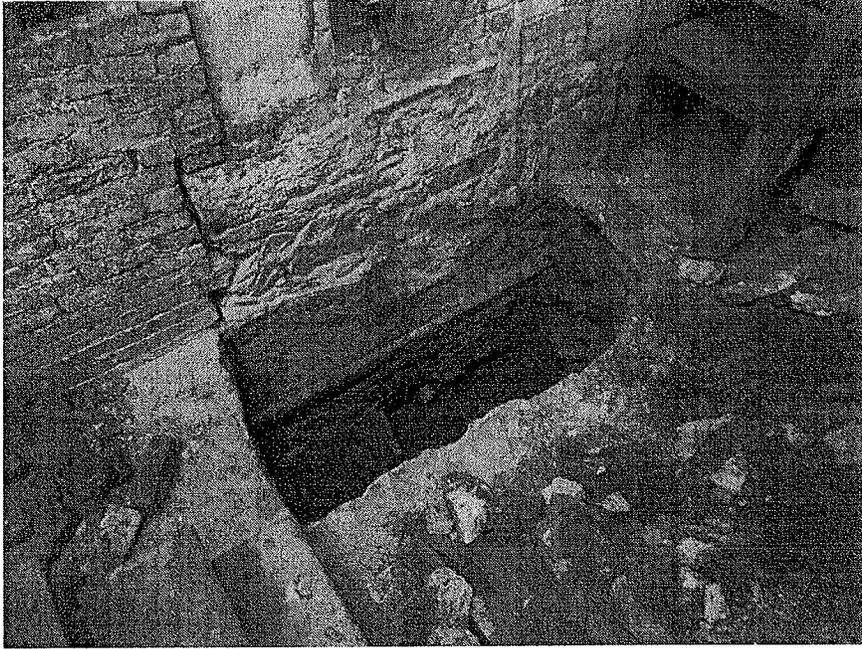
**Photo #1: TP-1 – Plan View**

The test pit excavations conducted along the interior side of the north exterior bearing wall (TP-1 and TP-3) indicate the foundation wall to be comprised of mortared fieldstones that extend to depths of 3.3 to 3.5 feet below the bottom of the basement floor slab. No footing was present at the bottom of the wall which was observed to bear on the fill deposit. Within the two test pits, the bottom of the exterior foundation wall varied from Elevation +3.6 to Elevation +3.9.

In regard to the underpinning of the perimeter foundation walls, remedial grouting and shotcreting of the existing wall would likely be required prior to underpinning to stabilize the wall based on its observed condition. Alternatively, approximate 3- to 4-foot widths of the wall could be entirely removed in sections along the building perimeter and incrementally replaced with new reinforced concrete footings and foundation walls.
