# ROOME & GUARRACINO, LLC

Reference: 100 Fellsway West, Somerville, MA

Subject: Structural Evaluation for Renovation

**GEOTECHNICAL ENGINEERING  
EVALUATION**

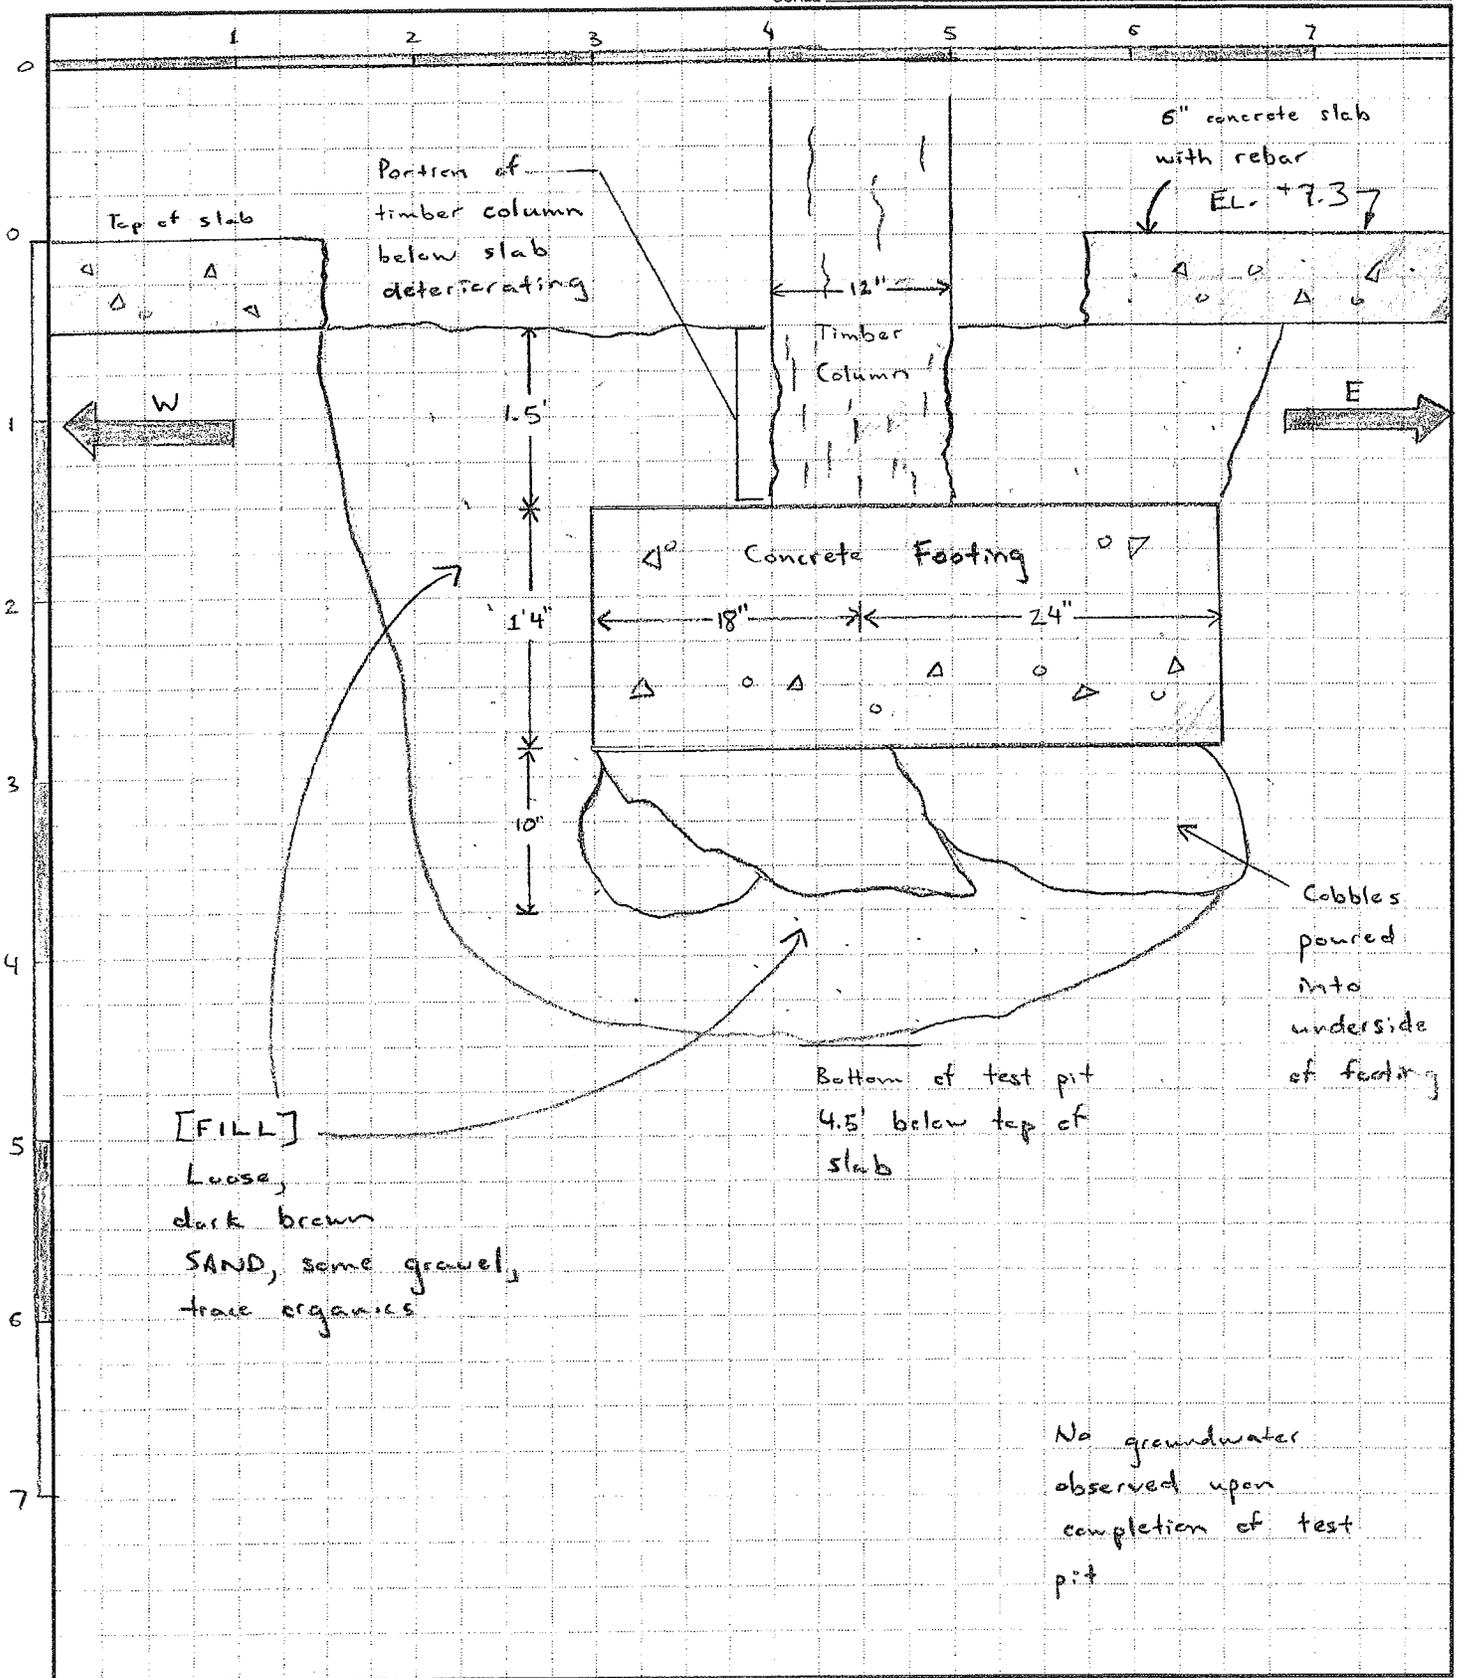
JOB 5400 TP-2 Plan View  
 SHEET NO. 3 OF \_\_\_\_\_  
 CALCULATED BY Scott Dennis DATE March 16, 2012  
 CHECKED BY CME DATE 3/30/12  
 SCALE 1" = 1'

Test pits performed adjacent to timber columns located within the building basement (TP-2 and TP-4), indicated the columns to be supported on isolated footings. The footings were observed to consist of a concrete base, varying in width from 3.5 to 4.5 feet and ranging in depth from 1.3 to 1.8 feet. At both test pits, the concrete was underlain by an unsorted mixture of cobbles and bricks varying from 10 inches to 2 feet in thickness. The bottom of the cobbles in the test pits extended to depths of 4.0 to 4.2 feet below the existing basement floor slab, corresponding to about Elevation +3.1, and were observed to terminate in the fill deposit. In general, the isolated footings exposed in the basement test pits did not appear to be "engineered" and typically consisted of a haphazard mixture of concrete, brick and cobbles.

Additionally, in both TP-2 and TP-4, the timber column was not observed to be concentric with the plan location of the underlying footing. At TP-4, the plan location of the timber column was observed to be at the outer edge of the footing concrete. It was also noted that the timber column at both test pit locations extended below the concrete floor slab and was significantly rotted to completely disintegrated within the depth that extended below the floor slab as indicated in the photographs contained in Appendix B. The cross-sectional area of the column was significantly to entirely compromised at both test pit locations.

Further, the isolated footings supporting the timber columns within the basement area are considered to be inadequately constructed due to the random arrangement of concrete, brick and cobbles that comprise the foundations. In addition, the eccentric column location relative to the plan area of the footings and the significant deterioration of the section of the timber column that extends below the floor slab further reduce the capacity of the foundation system. During our initial observations of the test pits located adjacent to the timber columns, it was recommended to Roome & Guarracino, LLC that temporary shoring be provided at the column locations to adequately support the compromised structural condition.
